Toastmaster® Service Bulletin

Bakery product jamming in Model TC14 and TC18 Conveyor Toasters

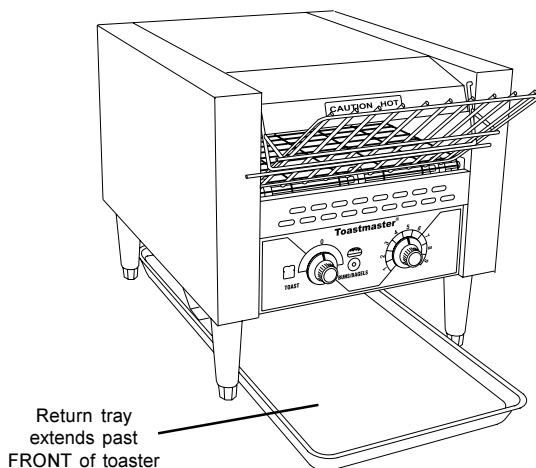
Figure 1 - Front-exit configuration

Some customers have reported jamming problems when operating Model TC14 and TC18 Conveyor Toasters. Many of these jamming problems can be solved by configuring the toaster for rear-exit operation. In this configuration, the product slides directly off the end of the conveyor belt and out of the toaster. This minimizes the chance of the product jamming against the roof of the toasting chamber.
